Stockman Mine Response to EES

Victorian National Parks Association
2014

The tailings dam

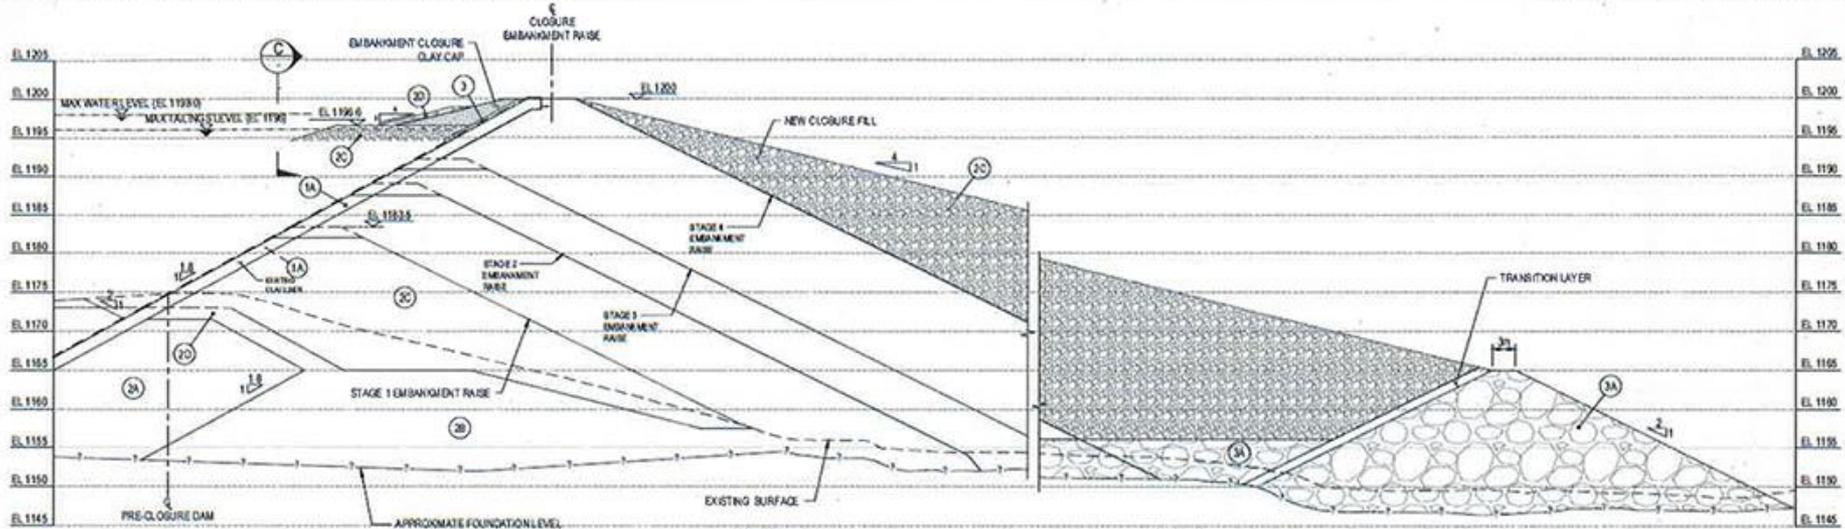
SECTION A C119
SCALE 1:300
CLOSURE - TYPICAL SECTION

- Written descriptions in the EES (eg Appendix B3, section 3) are sketchy.
- Cross-section diagrams (without any details) are tucked away in Appendix A to Appendix B3.

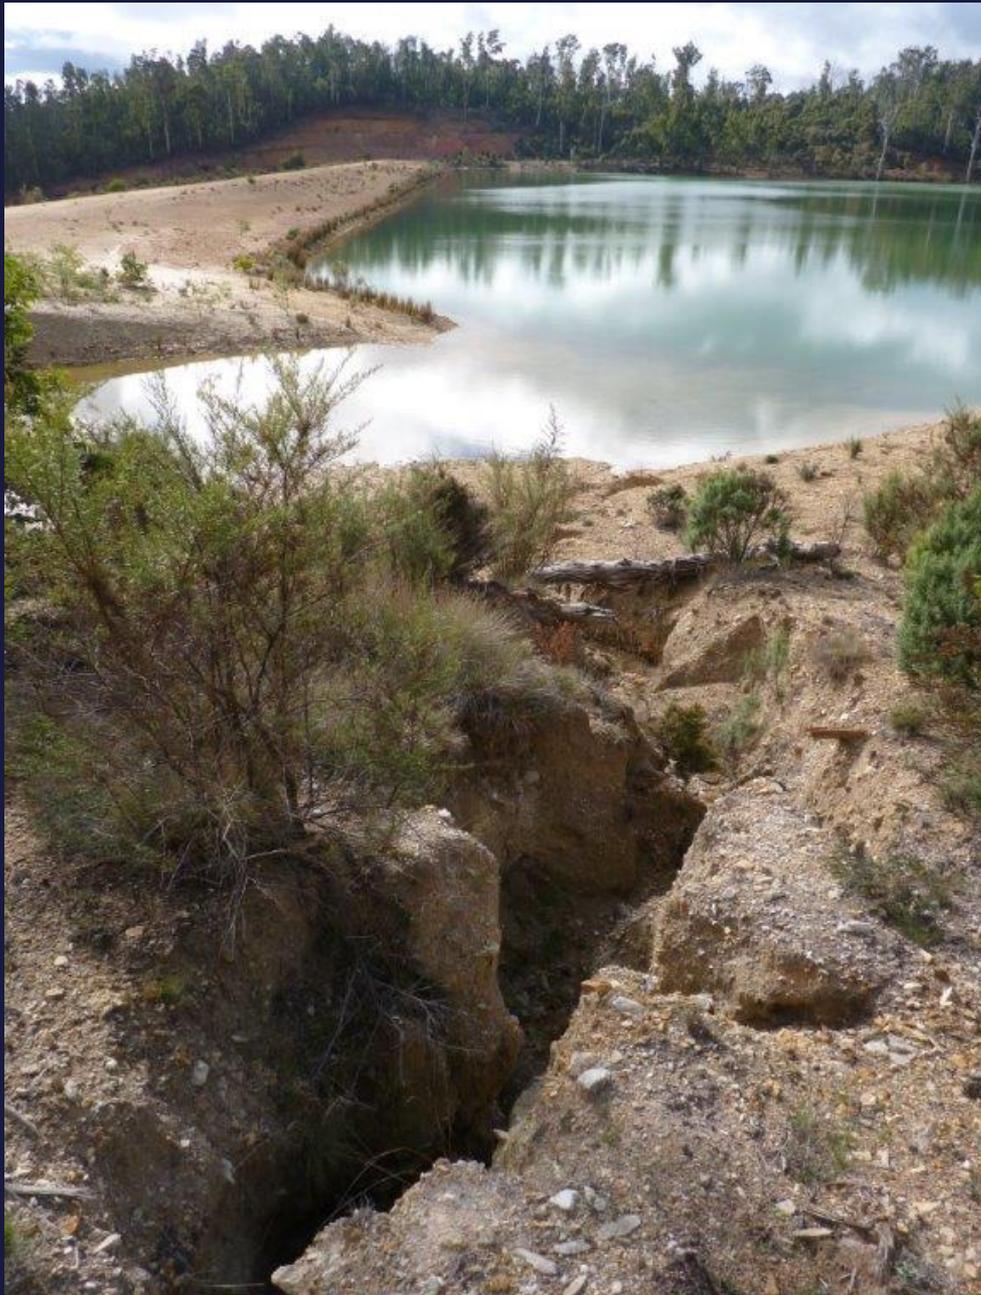
Erosion at
southern edge of
'Stockman' tailings dam.
June 2014
